6 National Dam Inspection Program
Briar Creek Dam (NDI ID PA-00651
DER ID 19-77, SCS ID PA-497),

PENNSYLVANIA. Phase I Inspection.
Report,

PHASE I INSPECTION REPORT
NATIONAL DAM INSPECTION PROGRAM

11 May 1979

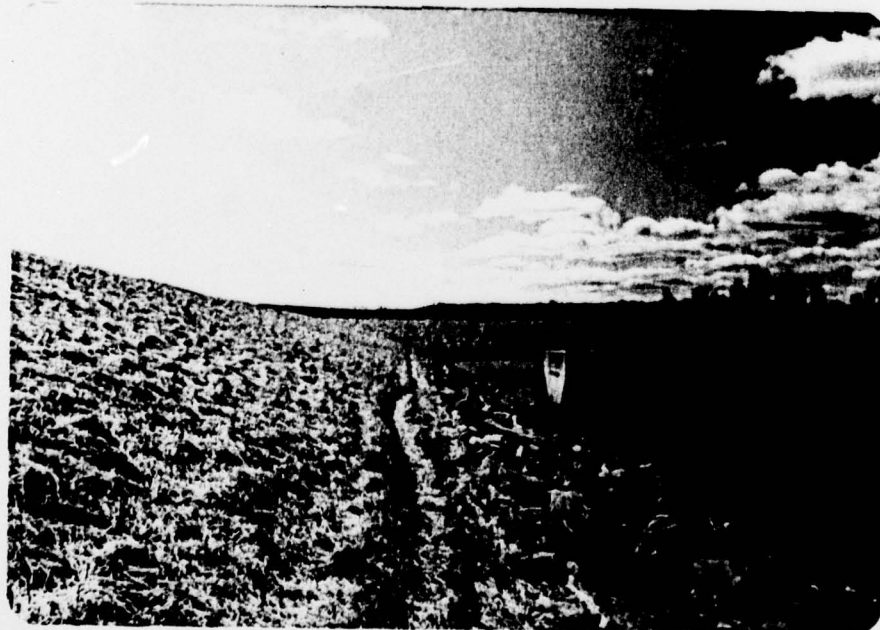
B. Upstream Slope

(2) Embankment. The design elevation of the top of the riprap on the upstream slope is El. 603.2, about 2.1 feet below the top of the riser pipe. This is 7.8 feet below the design 100-year pool level. The reason for selecting this elevation is not noted in the design computations. Lack of riprap on the upper portion of the slope creates an erosion hazard during flood conditions. Terminating the riprap below the top of the dam is a standard SCS design criteria. In view of the good

maintenance at the dam, erosion on the upper parts of the embankment would be repaired immediately after it occurred. This would make the erosion hazard negligible. Apparently the SCS considered the main spillway orifices to be the main spillway crest, as the riprap is 4.0 feet above the orifice crests. A more conservative designer would have selected the crest of the main spillway riser as the main spillway crest.

(2) Extend the riprap on the upstream slope to a reasonable height above the main spillway riser crest. Inspect the upstream embankment after each flood for evidence of erosion. Repair the embankment as necessary.

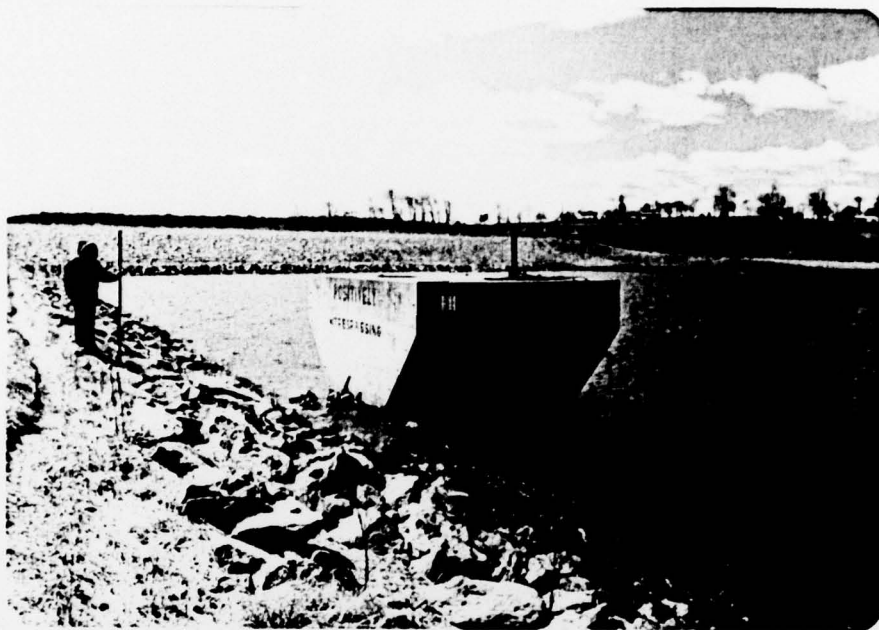
C. Riser Intake

c. Design Considerations. Although the main spillway design has been used successfully by the SCS for many years, it appears that the entrance to the conduit could possibly develop cavitation during certain flow conditions. Other design considerations are discussed in Sections 5 and 6.

(5) Implement the planned inspection of the main spillway conduit and riser to determine if elongation of the conduit and cavitation damage to the riser

have occurred. If pool conditions prevent the implementation of the inspection, the pool should be drawn down as required to provide the opportunity for inspection.

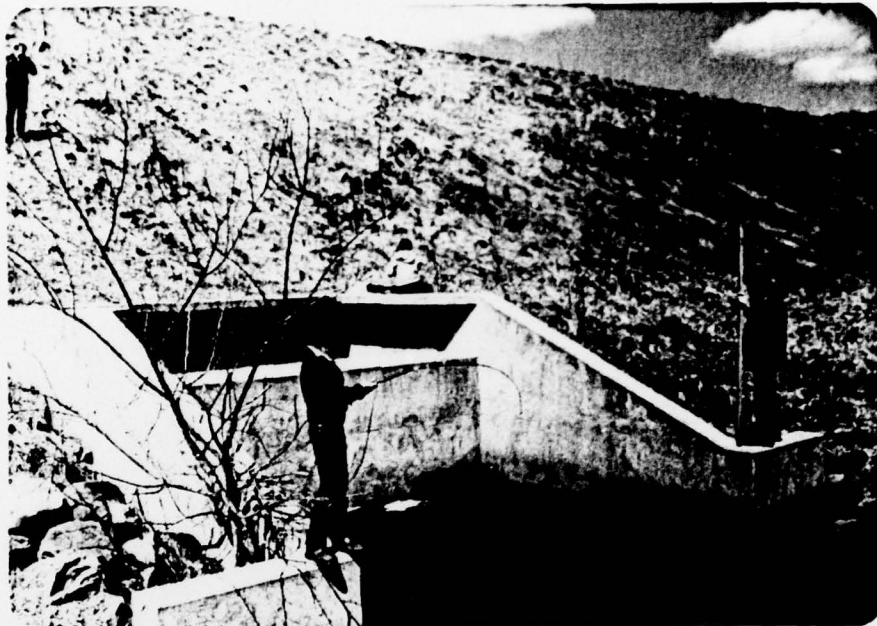
E. Impact Basin

(3) Appurtenant Structures. The gate for the outlet works is located sufficiently far upstream to be considered an upstream closure facility. The cause of the uneven riprap below the impact basin is unknown. The erosion hazard is minor. The slide in the auxiliary spillway approach channel is sufficiently far from the control section that it will not affect the hydraulics. Although the exact elevations of the control section are uncertain, it appears that at least part of it is above the design elevation. As the flood routing for the "Freeboard" storm was accomplished using LV on LH auxiliary spillway side slopes, and since the final design used LV on 3H side slopes, the auxiliary spillway crest being slightly above the design elevation does not significantly reduce the design capacity. Other observations concerning the auxiliary spillway are discussed in Section 6.

(6) As part of the regular maintenance program, remove the tree near the impact basin, replace the missing riprap at the impact basin, provide better control of foot traffic on the embankment, and continue efforts to remove burrowing animals.

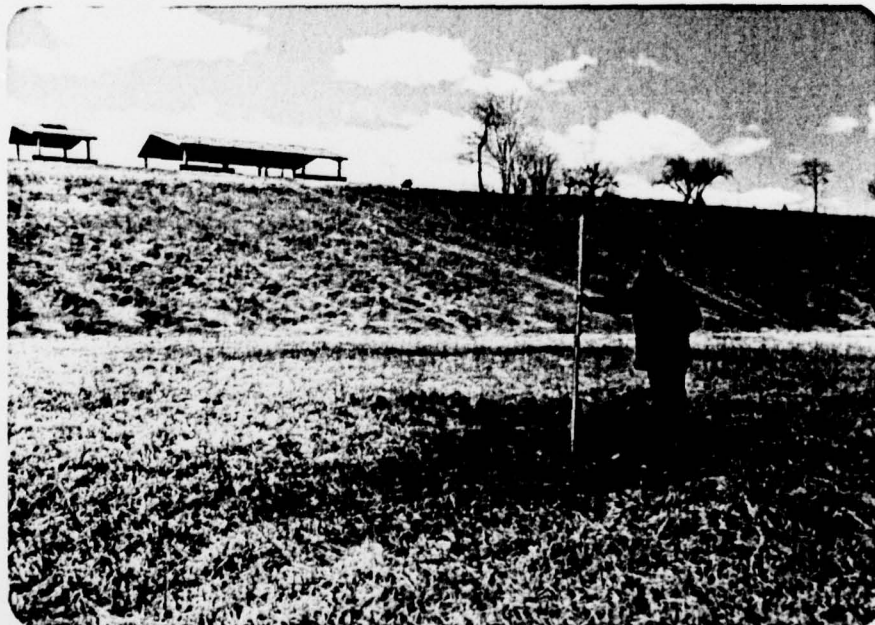
H. Sinkhole in Auxiliary Spillway

The auxiliary spillway is in good condition, The grass cover is in good condition except at 3 areas, where sinkholes had previously developed. The sinkholes have been filled but the grass cover has not reestablished itself. An area of the spillway approach channel has slid along the right bank. This area is about 400 feet upstream of the control section. A worn foot trail extends down the right bank slope. Burrowing animals inhabit the banks and bottom of the auxiliary spillway. The survey performed for this inspection revealed that the control section invert is between 0.2 to 0.9 foot above the design elevation. Part of the difference between the actual and design elevation may be explained by the uncertain survey datum as noted previously.

The sinkholes in the auxiliary spillway developed immediately after Tropical Storm Agnes. This was the only time flow occurred over the auxiliary spillway. As noted in Appendix E, the geology at the auxiliary spillway is complex. The logs of drill holes performed as part of the foundation exploration indicate that the embankment is not founded on either the fault or the solution-prone limestone. The caretaker is inspecting the sinkhole area frequently. Immediately after Tropical Storm Agnes, the SCS had engineers experienced with dams in limestone areas inspect the sinkholes and recommend repairs. Their report was not available

for review but the conclusions and recommendations were summarized in a letter to the Commonwealth. The recommendations were to backfill the sinkholes with a reverse filter. This has been accomplished. The conclusions were that sinkholes would continue to develop in the auxiliary spillway, that the sinkholes would not be a hazard to the embankment, and that repairing them as they developed is the only economical method of controlling them. There is no reason to doubt the validity of these conclusions.

(1) Continue to monitor the filled sinkholes in the auxiliary spillway. Should the sinkholes develop further or should others develop, assess their size, location, and reason for development to determine if the assumption that they are not a hazard to the dam is valid.
